## CASE STUDY: The Essential Seal Combination

Kinder Australia Products:	<p><u><a href="#">K-Sure® Belt Support System</a></u></p> <p><u><a href="#">K-Snap-Loc® Dust Seal System</a></u></p> <p><u><a href="#">K-Containment Seal</a></u></p> <p><b>The Essential Seal Combination</b></p>
Product Category:	Conveyor Skirting and Transfer
Product:	Concrete and quarried materials
Production Rate:	300 tonnes per hour
Belt Speed:	1 metre per second
Location:	Transfer area – awkward, obstructed area with very low clearance
Installation Date:	October 2016

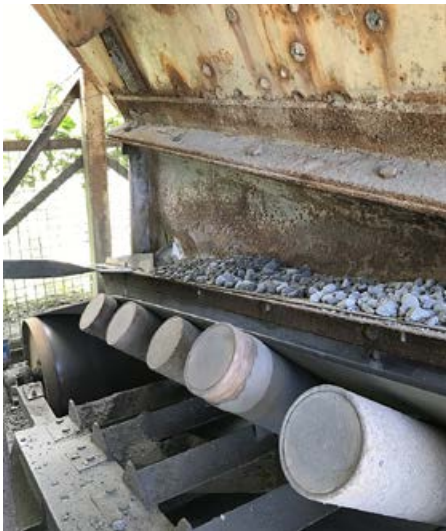
**ABOVE: Before image showing the customer's spillage problem due to ineffective material containment at the transfer point.**

Our established New Zealand quarry customer operates a busy concrete production plant. A transfer point located on one of their existing conveyor systems is situated in an awkward area for gaining reasonable access, inside/ underneath a drive-over bin. This was making the completion of any maintenance task such as the removal of spillage, very complicated.

Our customer had used SBR Black skirting rubber to surround the chute. However it was performing poorly and wasn't containing the transferred sand and aggregate material effectively. Spillage would find its way onto the inside of the belt and subsequently cause tracking issues, which would result in further spillage and downtime in order to clean-up the area and keep it hazard-free.

Ongoing adjustment of the skirt rubber required numerous bolts to be undone, adding further inefficiencies to ongoing maintenance.

To significantly reduce the maintenance time as well as the complexity of the skirt adjustment task, we advised our customer to install a combination of belt support and skirting products.

Firstly to replace the SBR rubber skirt, a **K-Snap-Loc® Dust System** was installed. Minimal tools were required for installation as the K-Snap-Loc® is securely mounted using a simple length of Unistrut mount. Ongoing adjustment is no longer necessary because the engineered polyurethane properties of K-Snap-Loc® are capable of self-adjusting to the correct and precise distance to the belt to contain the pressure of transferred material effectively.

Secondly, to stop material spillage that occurs through belt edge sag where the weight of the load at the transfer point is not sufficiently supported underneath by the conveyor rollers, our customer then installed a **K-Sure® Belt Support**. These low friction bars replace the existing rollers and provide consistent uniform support for the belt's movement.

Lastly, to ensure that the best possible wear life performance of the skirt and belt support is achieved, **K-Containment Seal** was installed inside the chute at the rear and also sides. The purpose of using the K-Containment Seal is to provide an extreme wear resistant protective layer for the vulnerable edges of the chute.

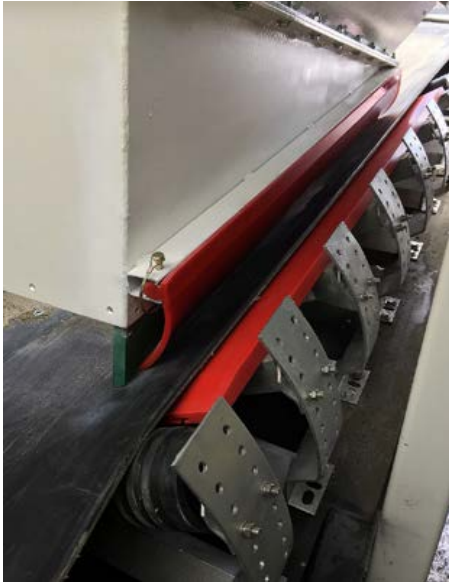
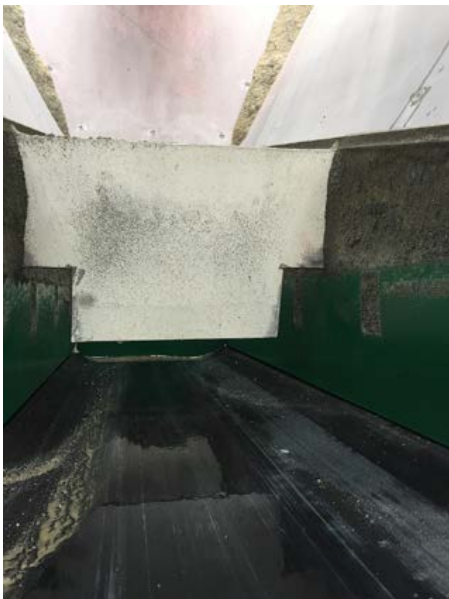
ABOVE: After image showing the installation of the product combination, outside and inside the chute. RIGHT: Video of effective transfer point in action >>[CLICK VIEW](#)
